Clutch

Product competence from EUROPART

Technical information

Failure diagnosis and causes of faults

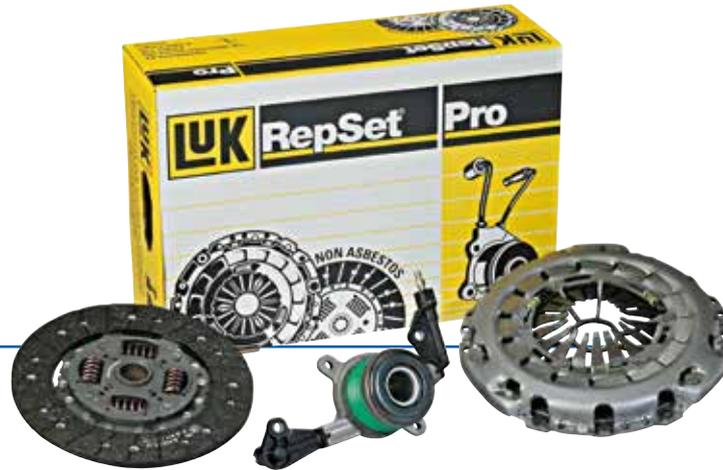
Clutch kit

Version automatic readjustment
 Ø 240 mm

Application range
 Engines with dual mass flywheel

Scope of supply
 with central clutch release

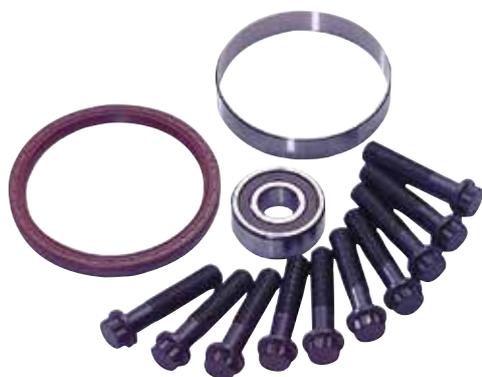
Fastening set for flywheel

Length 74 mm
Thread M16 x 1,5
Version complete

1 axial seal (outside ∅ 140 mm), 1 race (outside ∅ 120 mm), 1 pilot bearing (outside ∅ 62 mm), 10 bolts M16 x1,5

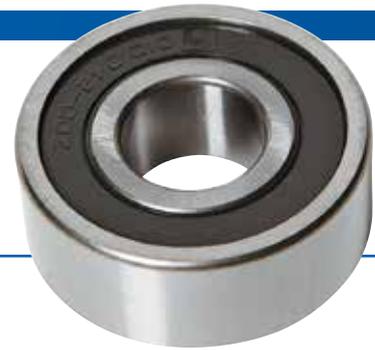
**Guide bearing for flywheel**

Inner \varnothing 25 mm
Outer \varnothing 62 mm

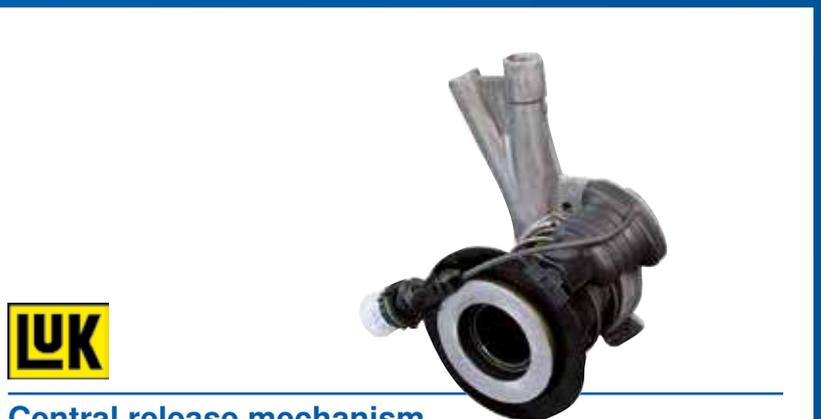
**Central release mechanism**

suitable for	Version	Operating liquid	Order no.	Comparative no.
Mercedes-Benz Atego I/II, Axor I/II, Unimog	with sensor	Brake fluid	9305 175 710	LuK 510 0057 10
Mercedes-Benz Atego I/II, Axor I/II	without sensor	mineral oil	9305 172 310	LuK 510 0123 10
Mercedes-Benz Atego I/II, Axor I/II	with sensor	mineral oil	9305 175 510	LuK 510 0155 10
MAN TGL	with sensor	mineral oil	9305 171 910	LuK 510 0119 10

Just like the clutch, the concentric slave cylinder is subject to natural wear that is not always possible to locate visually. To be on the safe side, replacing the concentric slave cylinder is also recommended at the same time as the clutch. The installation instructions from the vehicle manufacturer must be observed when installing and bleeding the concentric slave cylinder. Before a new concentric slave cylinder is installed, hydraulic release systems must be purged and then refilled in accordance with the specifications provided by the vehicle manufacturer.

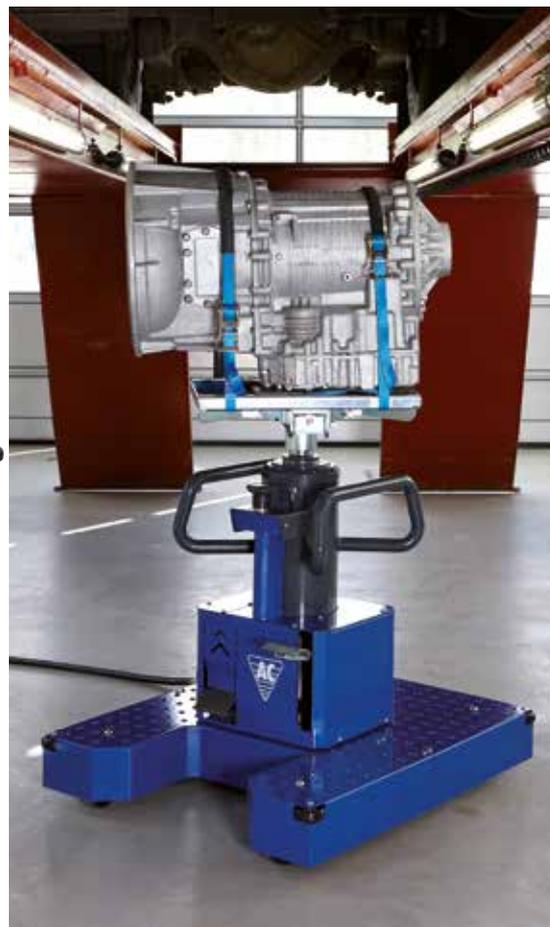
flexible for use in a pit as well as on the workshop floor under a platform, the telescopic cylinder makes it also ideal for transmission repairs, built-in manual foot pump for fine adjustment, fast and precise air-hydraulics with fast up and down travel, spring-mounted transport base secure against unintentional movements when lifting from 800 kg, dead-man control and safety valve for maximum safety, can be used for all traditional lifting tasks

Load capacity	15 t
Version	floor-running
Seat-Ø	60 mm
Height, max.	2206 mm
Height, min.	921 mm
Piston stroke	1285 mm
Cylinder-Ø	60 mm
Operating pressure	12 bar
Air consumption	350 l/min
Base plate	844 x 1004 mm

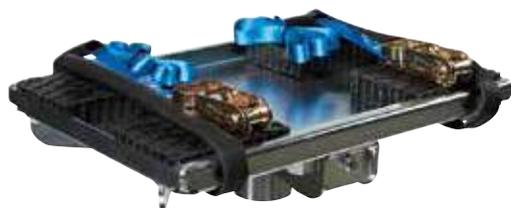
Transmission plate

can be tipped +/- 10° to all sides for the precise removal and installation of transmissions, extremely flat construction offers many possible applications, sturdy construction ensures optimum stability

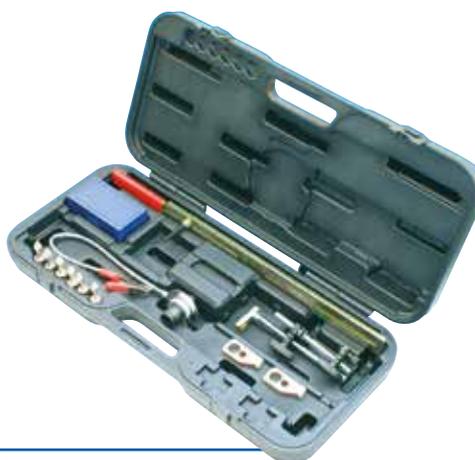
Testing tool kit for dual mass flywheel

Tests can be performed on the vehicle with the clutch removed, the tests consist of inclination tolerance (axial bearing play) and clearance angle (rotation of the secondary disc in relation to the primary disc until the spring pressure is applied), can be used universally, easy to operate, allows clean, professional and precise work

Application range
fast and professional wear test of the dual mass flywheel

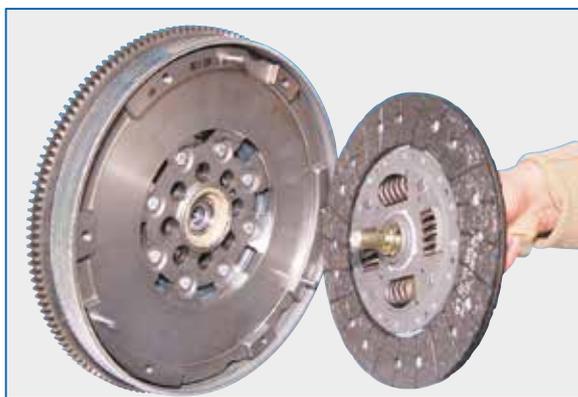
**KLANN****Clutch centering tool****for trucks with single/dual disc clutch**

single and dual disc clutches of trucks and tractors can be correctly centred towards the engine using the centring mandrel set

Before the clutch pressure plate is screwed into position, the clutch disc must be centred on the flywheel using an alignment tool that is guided through the pilot bearing. The clutch pressure plate must then be screwed onto the flywheel evenly, one section at a time and tightening the opposite screws in each step. In doing so, the specified tightening torque must be observed. The two parts of the clutch bell must be accurately centred in relation to each other. The centring ring or the centring pins and bores must be checked for wear. Later, when pushing together the engine and transmission, ensure that the two assemblies are precisely aligned and that the gearing of the transmission input shaft is very carefully threaded into the hub gearing on the clutch disc.

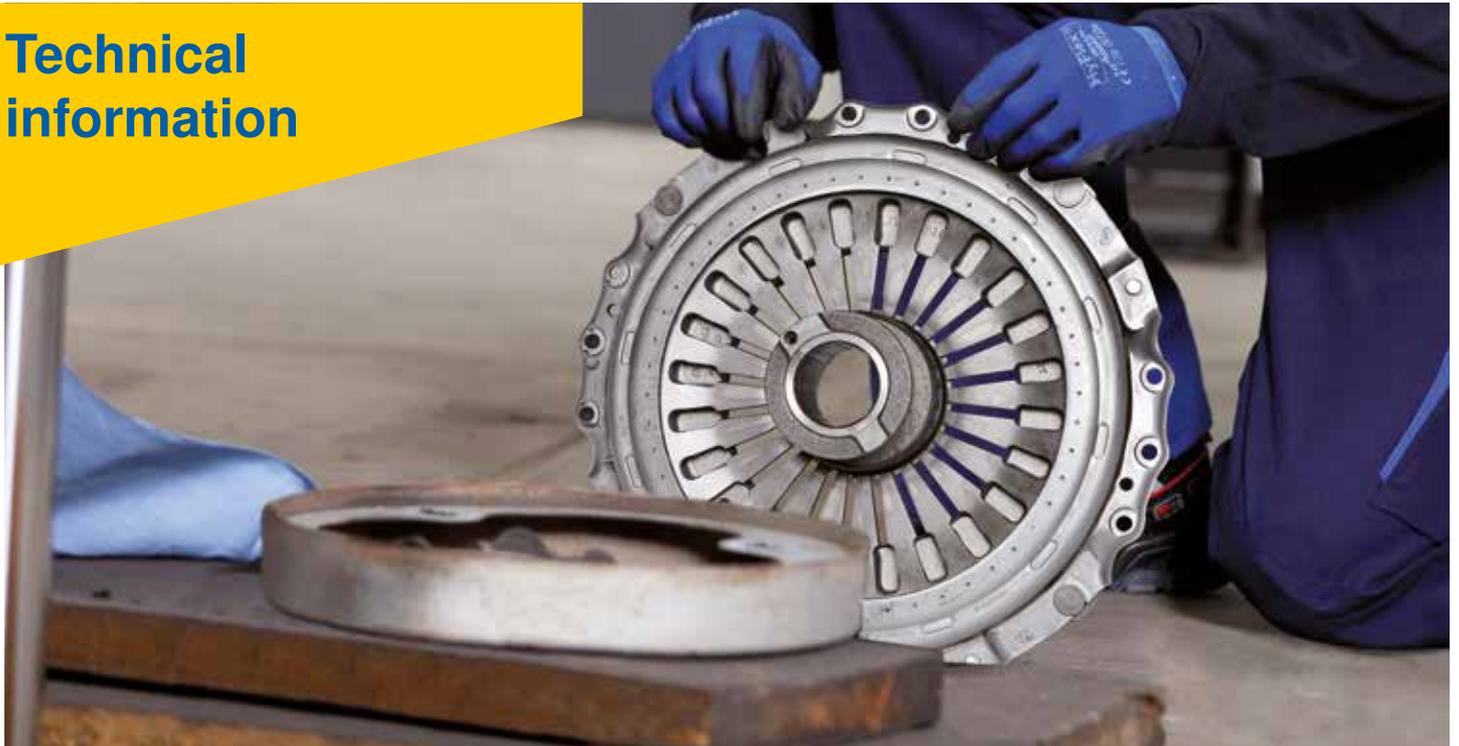
Certain criteria must be taken into account and a specified procedure must be followed when assessing faults on the clutch system, when diagnosing damage and when locating and correcting faults to ensure that the troubleshooting processes are efficient and have a lasting impact.

1. Reason for complaint
2. Troubleshooting
3. Damage diagnosis
4. Fault elimination

The reason for the complaint provides the basic information for the subsequent troubleshooting process, which will identify one or multiple causes. A visual inspection or, if applicable, a test measurement must be performed on parts that are still installed or that have already been removed. These tasks will provide information about the correct damage diagnosis, leading to the affected clutch components being repaired or replaced.

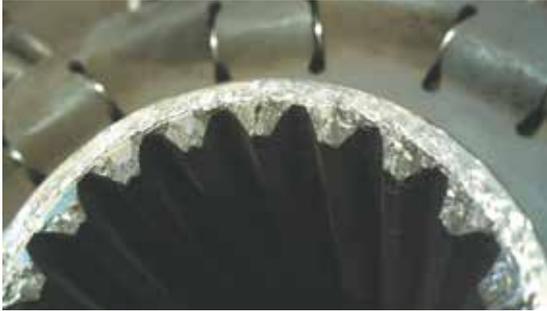
Damaged spline hub profile

- Installation error
- > Force was applied when the transmission shaft was threaded into the hub splines of the disc (disc was not centred during installation)
- Incorrect disc

Replace the clutch
Check the transmission input shaft

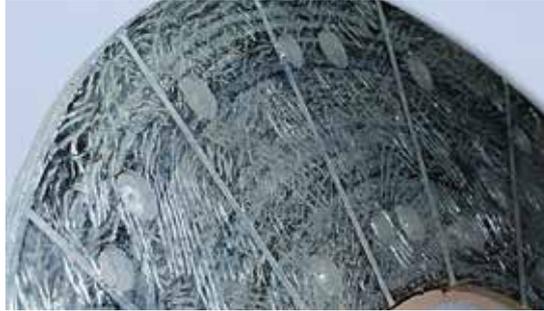
Scoring on the lining (flywheel side)

- Flywheel not replaced
- Friction surface on the flywheel not reworked
- > Scoring in the flywheel are introduced on the friction lining

Replace the clutch and flywheel

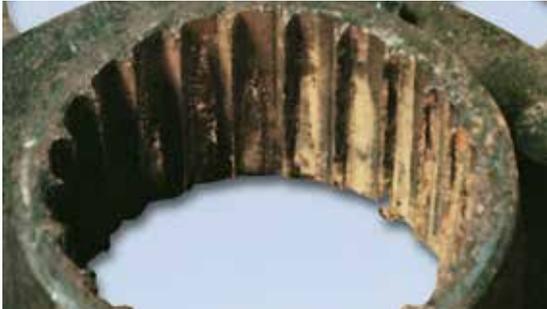
Spline damaged and worn to a taper

- Missing or faulty pilot bearing
- Parallel or angular displacement between the engine and the transmission
- Bearing arrangement of the main transmission shaft or of the transmission input shaft faulty
- Vibration damage
- Gearing on the transmission input shaft worn

Check the pilot bearing and replace if necessary
Check the bearing arrangement of the transmission shafts
Replace the clutch

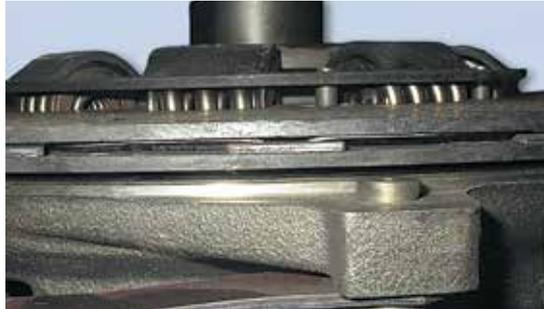
Lateral running deviations shown by the clutch disc (lateral run-out/deformation of the lining pad retainer)

- Clutch disc was not checked for lateral run-out before installation (maximum of 0.5 mm permitted)
- Shipping damage
- Installation error
- > The clutch disc was deformed when the transmission and the engine were pushed together
- > Engine or transmission released when being pushed together

Replace the clutch

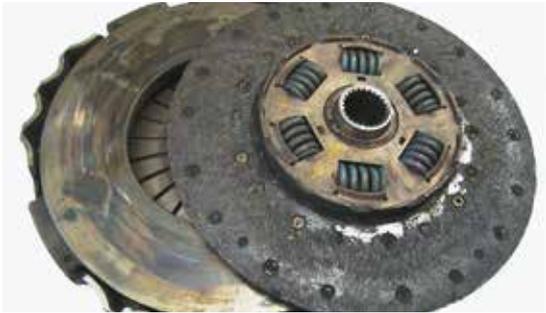
Overheating tracks on the pressure plate; friction linings burnt

- Thermal overloading due to:
 - > Driving errors (clutch allowed to slip for a long period of time during start-up and when shifting gears)
- Release system stiff or faulty
- Wear on clutch disc exceeds the wear limit

Replace the clutch
Check the flywheel and release system

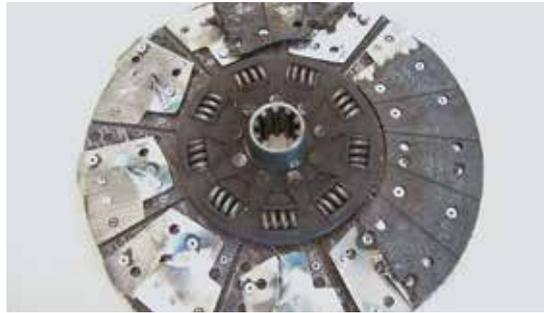
Burst Lining

The speed of the clutch disc was higher than the burst speed of the lining. This condition occurs when the vehicle is drifting and the clutch is engaged and if the speed of the vehicle is higher than the corresponding maximum speed of the engaged gear. This damage is not related to the engine speed — the decisive factor is the speed of the main transmission shaft

Replace the clutch

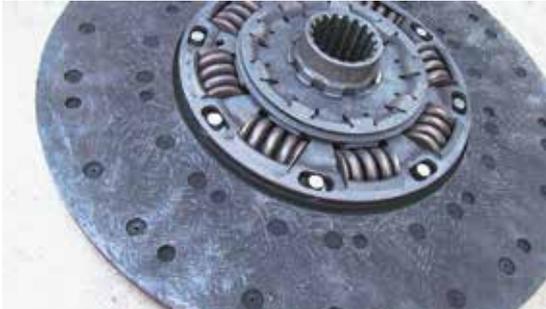
Lining area carbonised

- Thermal overloading due to:
 - > Driving errors (clutch allowed to slip)
 - > Rotary shaft seal for engine/transmission leaking

Replace the clutch
Rectify the leak

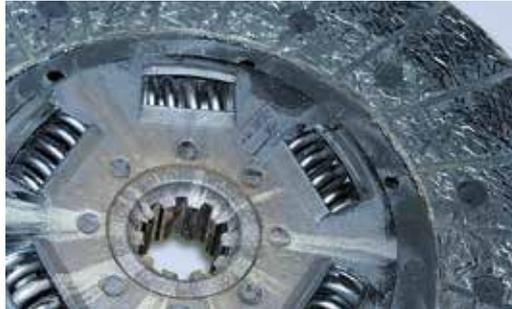
Lining greased or oiled

- Hub covered in excess grease
 - > Excess grease on the hub profile was not removed
- Faulty rotary shaft seal on the engine or transmission

Replace the faulty rotary shaft seal
Clean the parts; replace the clutch if necessary

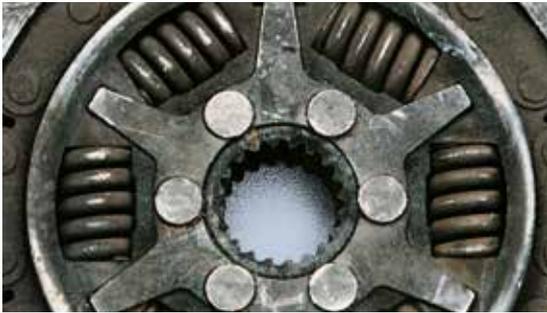
Contact tracks on the torsional damper

- Installation error
- > Disc installed in the wrong position
- Incorrect disc or clutch

Replace the clutch; ensure that the installation position is correct

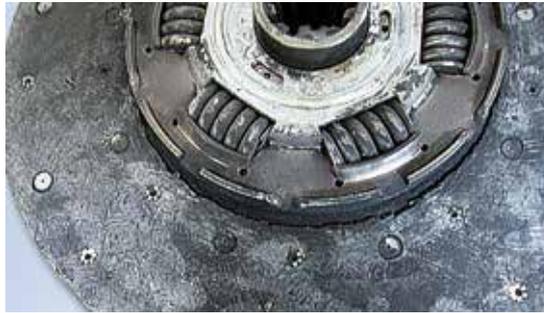
Lining worn down to the rivets

- Lining wear
- > Vehicle has been driven despite the fact that the clutch is slipping
- Driving error
- > Clutch allowed to slip for too long
- Incorrect clutch
- Faulty release system

Replace the clutch; check the flywheel

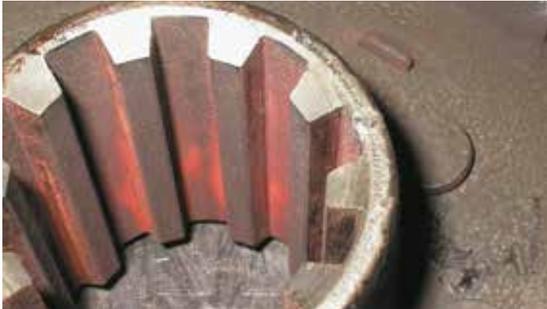
Rust and corrosion on the hub splines

- Hub splines not greased

Remove rust from the hub splines and grease them; replace the clutch if necessary

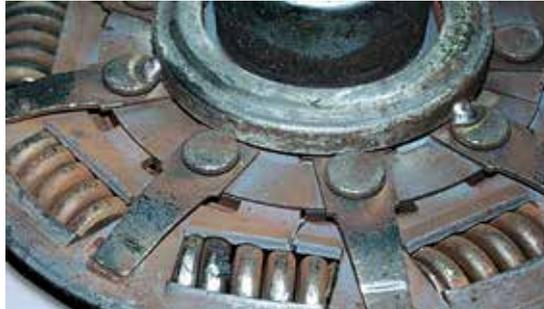
Grease hole plug for the torsional damper destroyed

- Driving error
- > Torsional damper overused as a result of driving at a low speed
- Faulty release system
- Incorrect clutch disc installed

Replace the clutch; check the flywheel
Replace the faulty parts of the release system

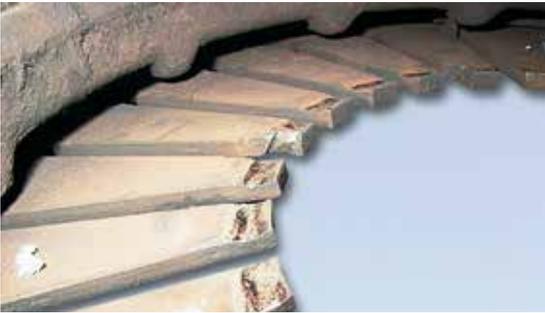
Diaphragm spring fingers worn

- Incorrect pre-load on the release bearing
- Faulty release bearing
- Release bearing seized

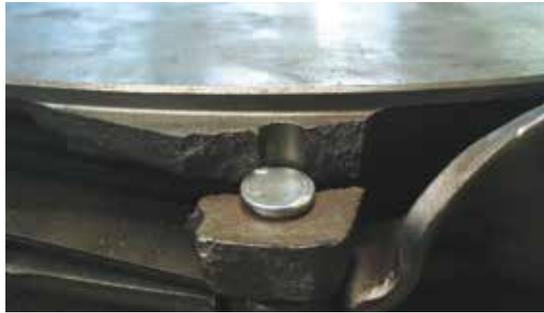
Cam breakage

- Clutch dropped
- Shipping damage

Replace the clutch

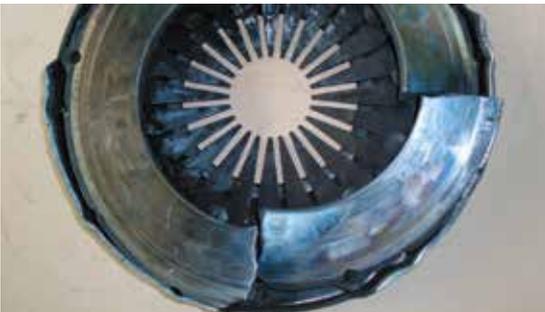
Pressure plate broken

Clutch slips; Clutch fails to disengage

Replace the clutch, flywheel and slave cylinder as necessary

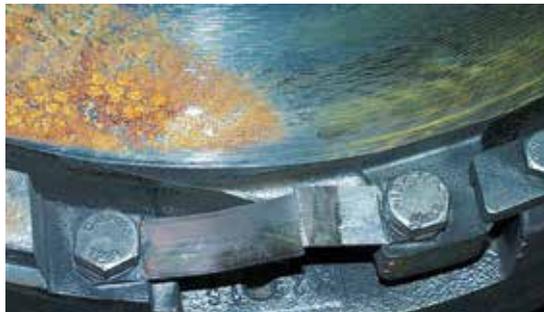
Tangential straps broken

- Play within the powertrain
- Operating error
 - > Gearshift errors
 - > Improper "tow start" of the vehicle

Replace the clutch; check the powertrain

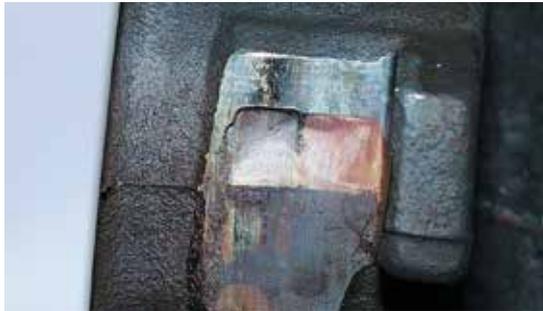
Release fork carrier on the release bearing worn

- Release fork worn
- > Bearing arrangement on the release shaft worn
- > Guide sleeve worn

Check the release system; replace faulty parts

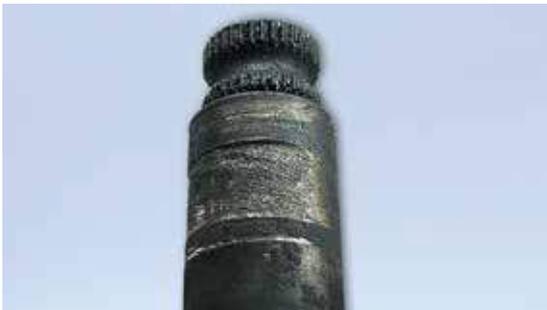
Release fork shaft stiff

- Bearing arrangement on the release fork worn

Check the release fork shaft; replace if necessary
Check the release bearing

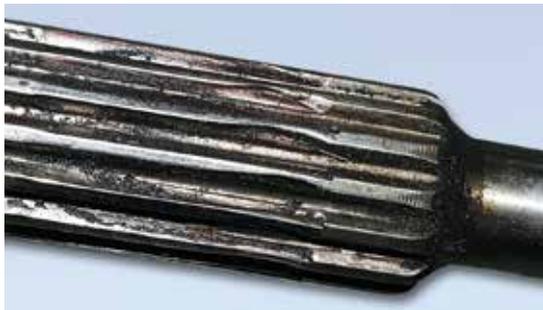
Transmission input shaft worn

- Transmission input shaft not greased/replaced
- > Clutch disc sticks on the gearing and therefore cannot disengage

Check the transmission input shaft; replace if necessary
Check the clutch; replace if necessary

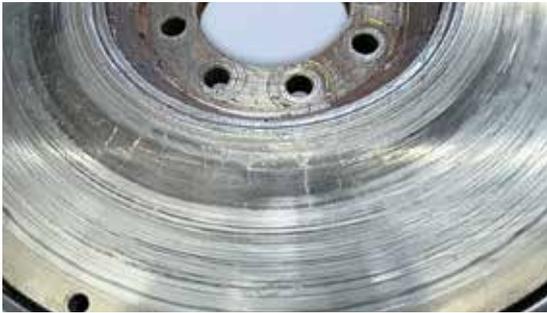
Flywheel shows temper colours, scoring and heat cracks

- Thermal overloading due to:
 - > Driving errors (clutch allowed to slip)
 - > Flywheel not reworked/replaced

Replace the clutch and flywheel

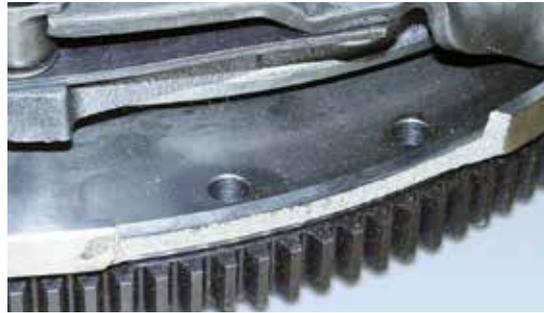
Centring ring of flywheel broken

- Installation error
 - > External centring not observed
 - > Mounting screws tightened unevenly

Replace the flywheel

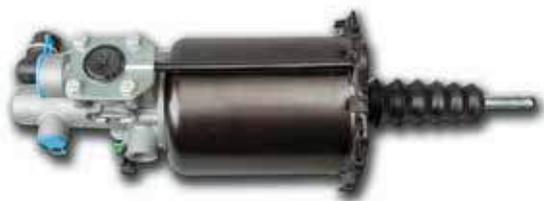
Image 1: Clutch booster with an extended ram

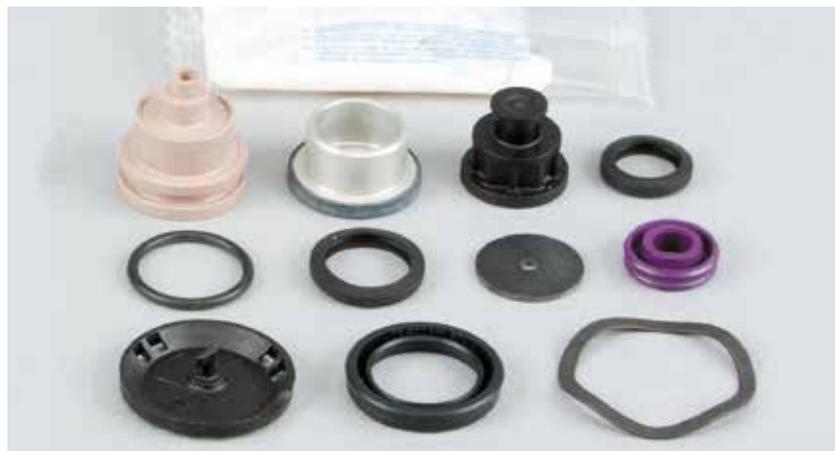
Image 1: Repair kit for clutch boosters operated with DOT 4 brake fluid

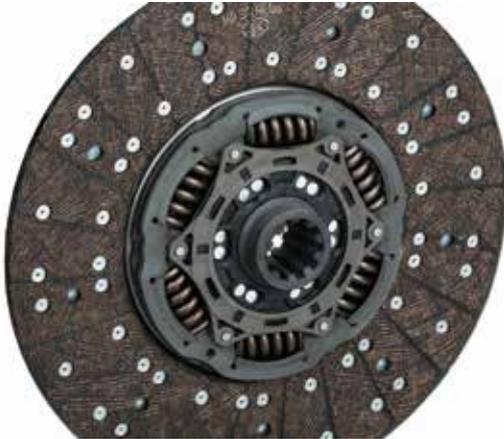
Clutch disc with new first stage damper Six spring torsional damper with first stage damper for higher capacity

Six spring damper with first stage damper

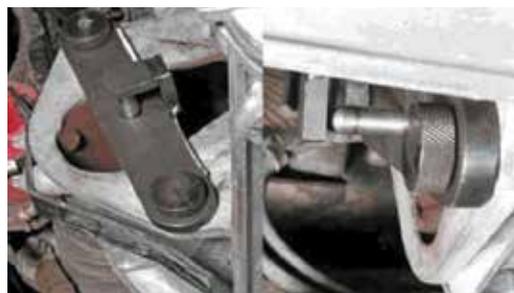
Image 2: Adjustment device from the vehicle manufacturer
